HIGHWAY RESEARCH REPORT

SOME CHEMICALS FOR CONTROL OF EROSION CAUSED BY RAIN

72-04

Some Chemicals for Control
of
Erosion Caused By Rain

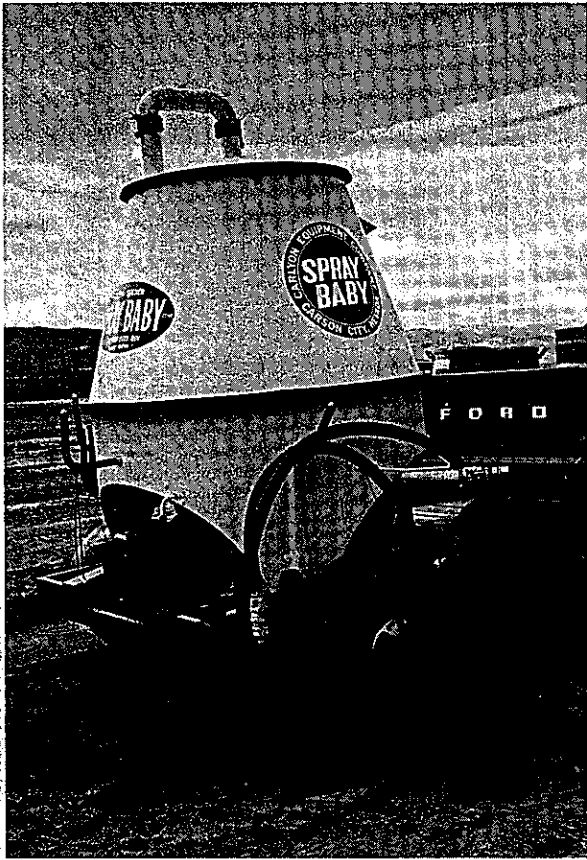
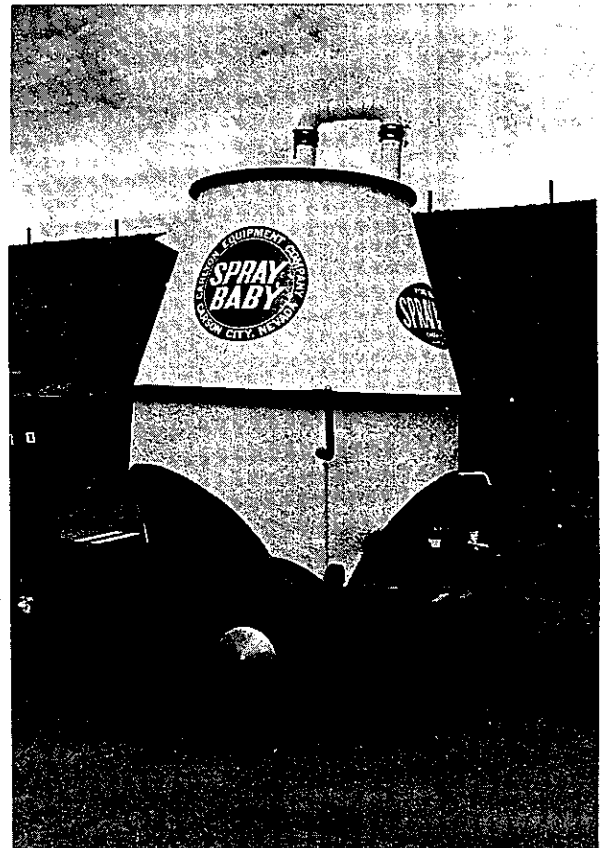
Plate 4

Rental spray rig used
to apply all products
included in this test.

All products were prepared and applied by personnel of the Materials and Research Department. The trailer-mounted sprayer pictured in Plates 4 and 5 was used for every application. The tank had a 150-gallon capacity which was more than adequate for the size of the test plots. The inside of the tank was marked at 5-gallon intervals to facilitate the proportioning operations in the field. A continuous and vigorous agitation system is built into the sprayer to assure delivery of a uniform mixture through the spray nozzle. The pump is driven by a $7\frac{1}{2}$ HP Briggs and Stratton 4-cycle engine.

The proportioning, mixing, and spraying operations all went smoothly and without equipment failure. Two problems were experienced with the sprayer, both of which have subsequently been corrected by the manufacturer. The pump size was too small and did not deliver enough pressure at the nozzle, and for some of the materials, the agitation was too vigorous and resulted in a frothy mixture which would not penetrate the soil well. For this project a smaller diameter nozzle was used to maintain pressure, and a chemical antifoaming agent was added to those products which exhibited the foaming property.

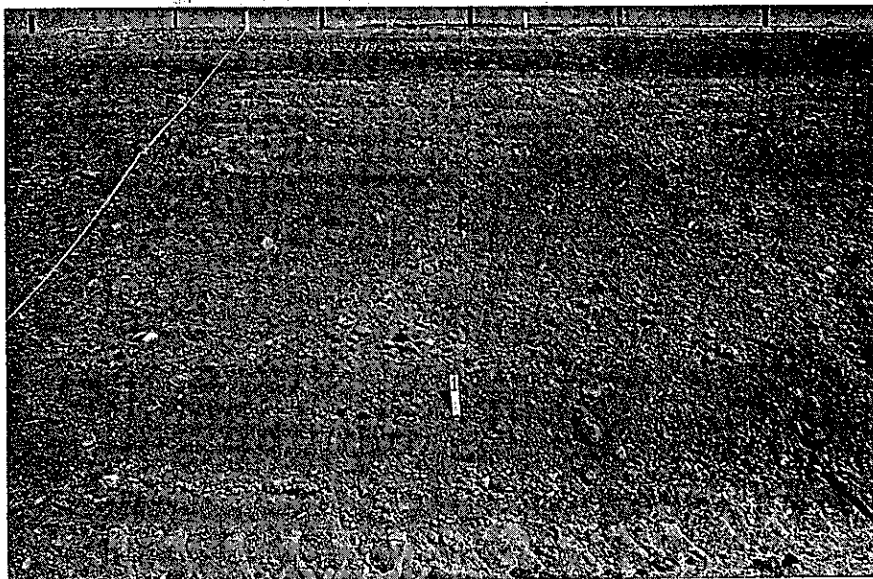
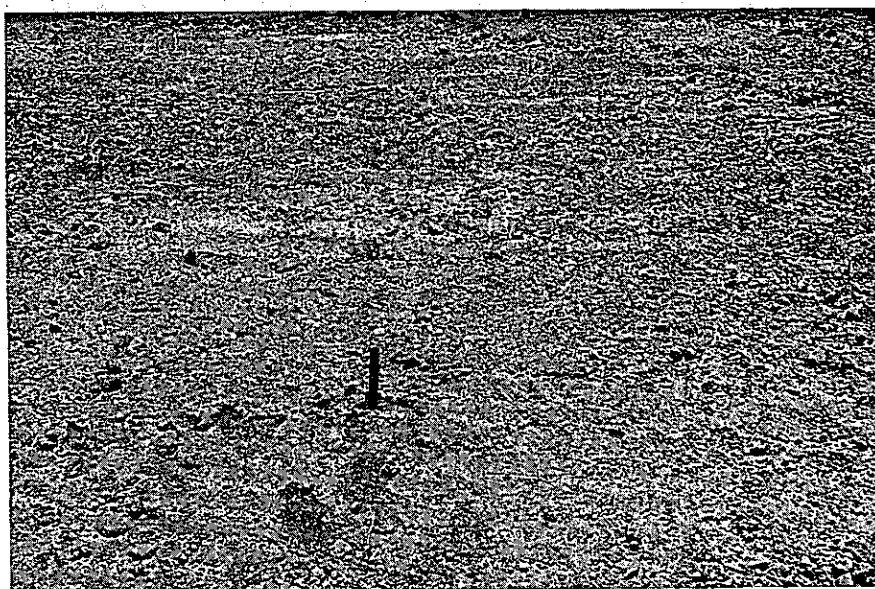
Control

2-24-71

7-22-71

Figure 1 shows the layout of the test plots, provides data on the cut slope characteristics and lists the material applied to each test plot. The control plots shown in Plates 8, 17 and 27 were left untreated as a basis for comparison. Plate 6 shows the test area on the day that the applications were completed. Plate 7 shows the appearance of the test area after the spring rains. No erosion can be seen that compares with the erosion in Plates 1, 2 and 3. The intensity of the spring rains was too low to cause any erosion even in the control plots. Plate 7 shows two features which were the result of failure to properly communicate our requirements to the contractor and Resident Engineer. The toe of all of the test plots was regraded when the contractor prepared the shoulders prior to paving. Although probably not significant in evaluating erosion, it definitely reduced the quantity of water collected on the slope and the distance over which the water had to run on the treated slope. The roller that was used to punch the straw into the rest of the slopes on the job was rolled across the top of all of the test plots and encroached on the sides of the test plots at either end of the test area. This is an extremely serious problem in that it breaks the continuity of the surface allowing water to get under the treatment. Since the rainfalls were gentle no damage resulted but the combination of water collecting basins and breaks in the surface permitted germination of native seeds all across the test area. Few natives germinated elsewhere. Apparently the punched holes acted as catchment for seeds blowing in from outside the top of cut and for rain water and the plants got an early and healthy start.

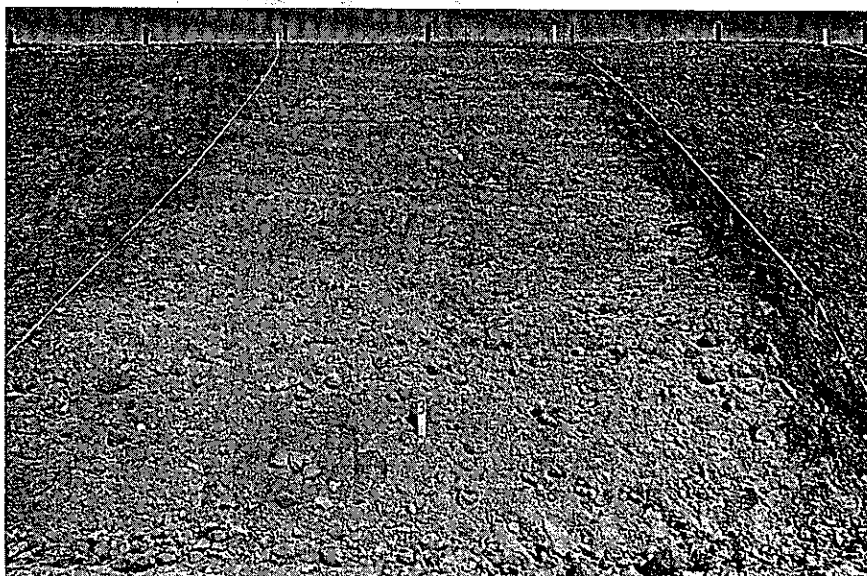
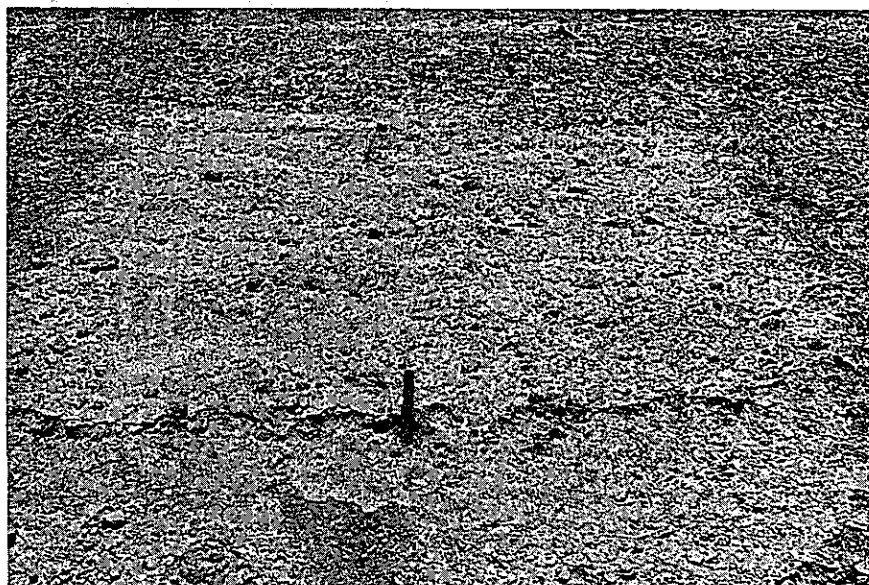
Plate 10

Curasol AE

Plates 10 and 16 show the appearance of the Curasol AE treated test plots.

Four months of weathering caused the Curasol AE crust to soften but it still maintains its integrity and serious erosion is not anticipated. The only vegetation present on these plots occurs in the roller path and consists primarily of native plants but with some barley and rye on the plot that was seeded.

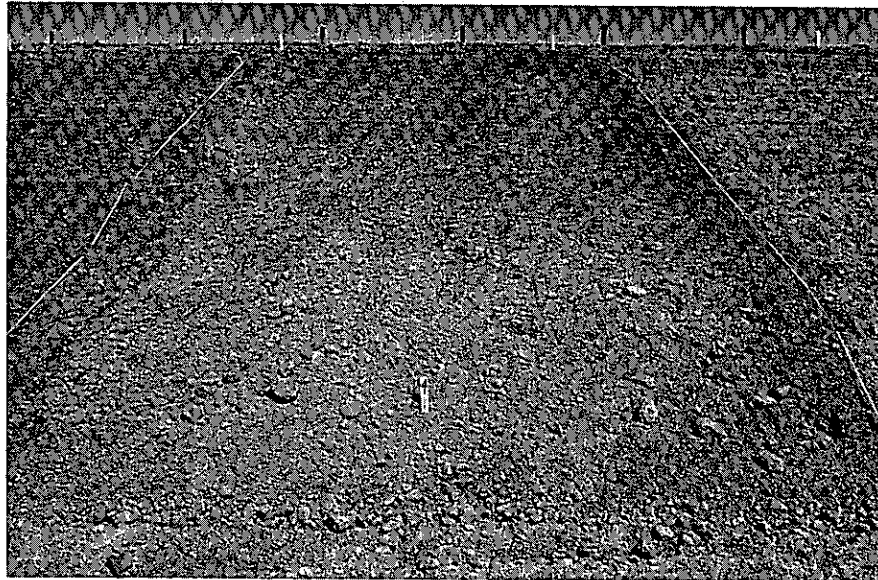
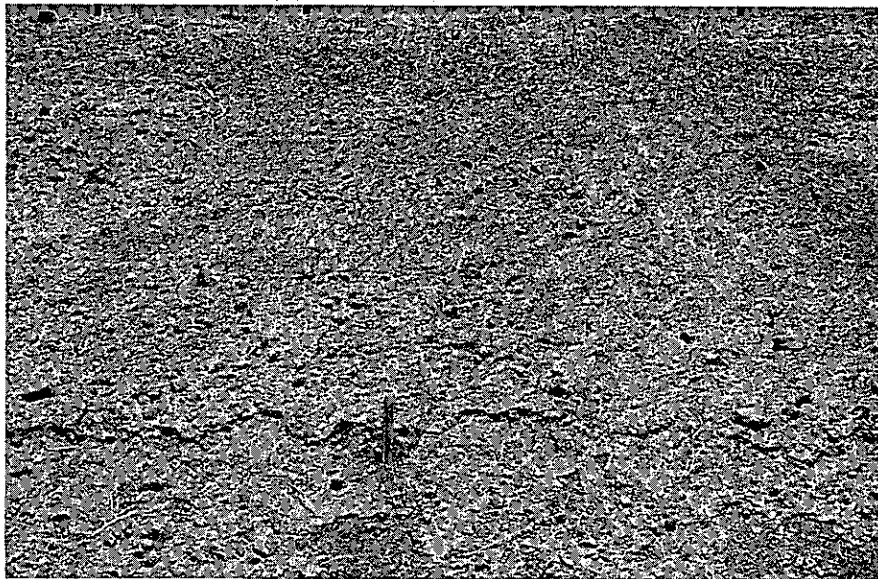
Ecology Control - Seeded

Plates 11 and 20 show the appearance of the slopes that were treated.

Weathering of the Ecology Control test plots has resulted in a softening of the crust. This crust appears to still be continuous and may provide some protection against serious erosion. The unseeded test plot was nearly barren of vegetation (a few native plants in the roller path) and the seeded plot has a few scattered native plants and barley, primarily in the roller path.

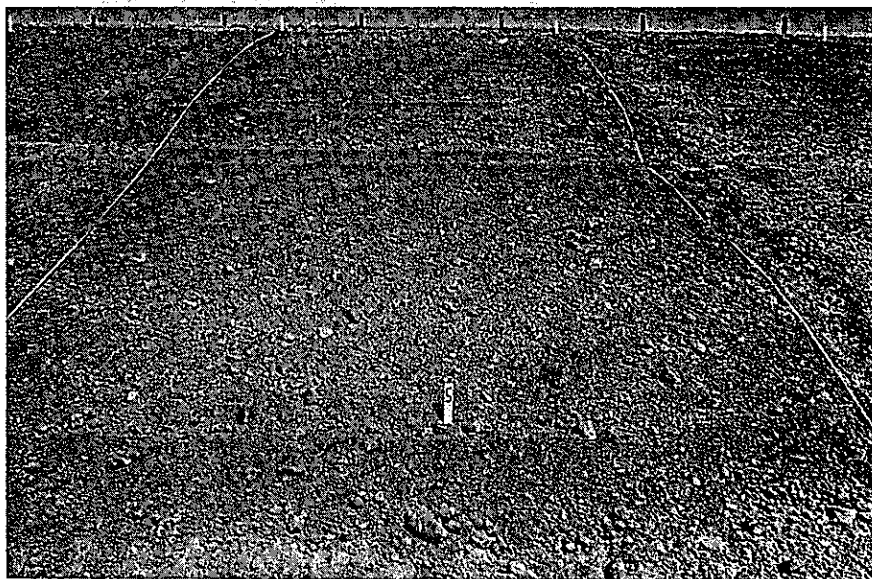
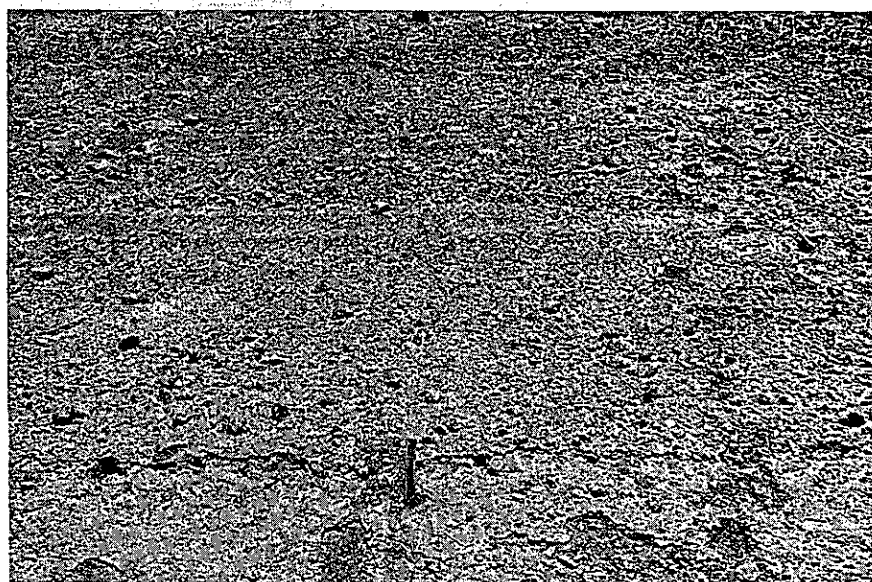
Aquatain

Plates 12 and 21 show the test plots that were treated with Aquatain.

After four months of weathering and spring rainfall the crust was no different than that formed on the untreated test plots, although some of the green coloring remained. Both the seeded and unseeded plots remained virtually bare except for the area over which the roller traversed. Some native plants as well as the seeded grasses sprouted in the roller path. Erosion is anticipated on these test plots. The unseeded test plot was damaged by human footprints.

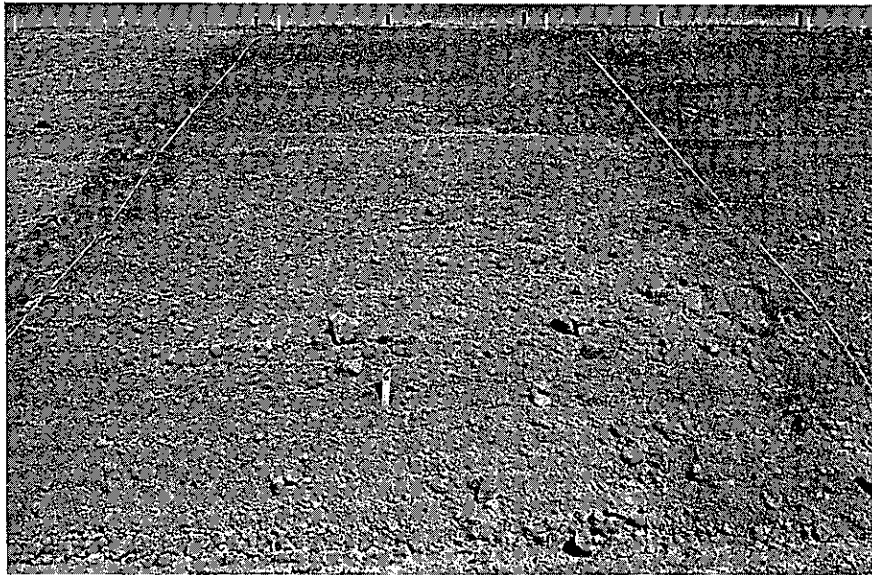
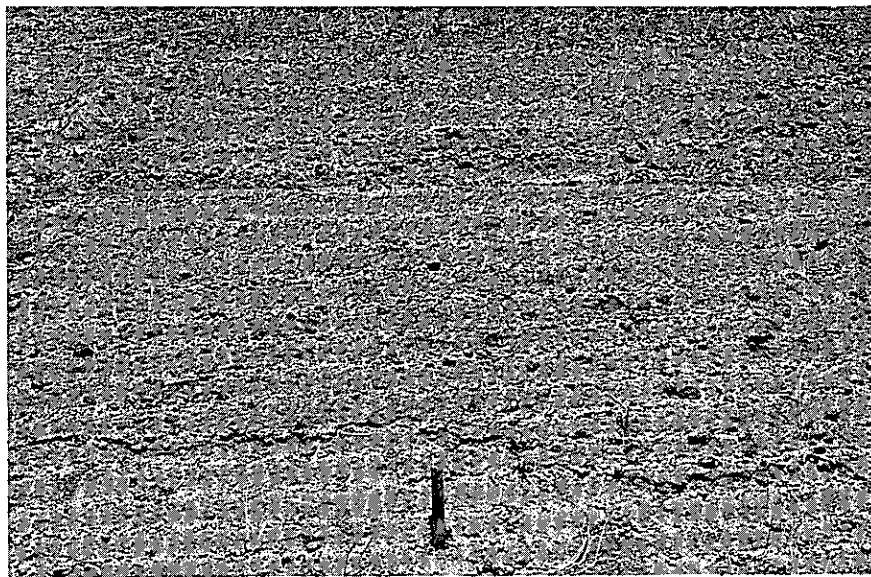
Plate 13

Erode-X - Seeded

Plates 13 and 24 show the test plots treated with Erode-X.

Weathering of the Erode-X treated test plots has resulted in a softening of the crust. This crust is continuous however, and may give some erosion protection. The unseeded test plot is nearly barren and the seeded plot has some native plants and barley which are concentrated in the roller path.

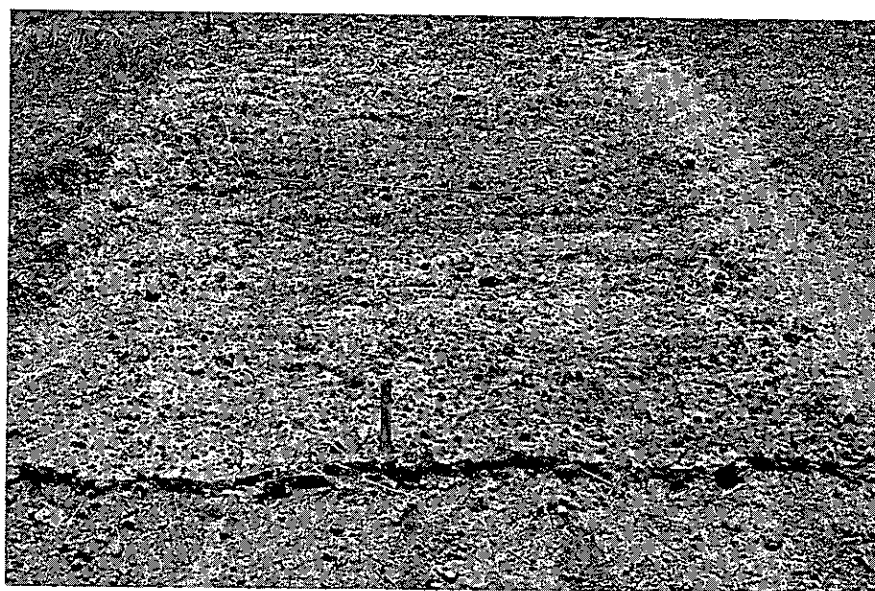
Plate 15

Orzan

Plates 15 and 23 show the test plots treated with Orzan.

Aging of this material results in an extremely hard thick crust which contains numerous shrinkage cracks. These cracks tend to heal themselves upon saturation of the material and then reform upon drying. The material clearly demonstrated its solubility in water, by developing a crust on the slope below the toe as a result of the light runoff that occurred this spring. These test plots are barren except in the roller path where native plants and some barley in the seeded plot did develop. This material will probably provide satisfactory erosion protection for one season in areas of light rainfall or areas of short duration rainfall.

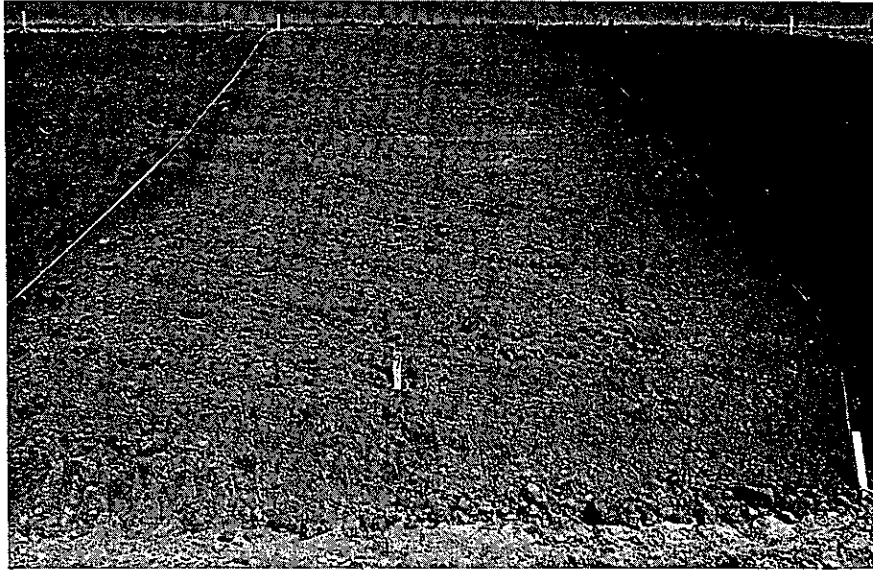
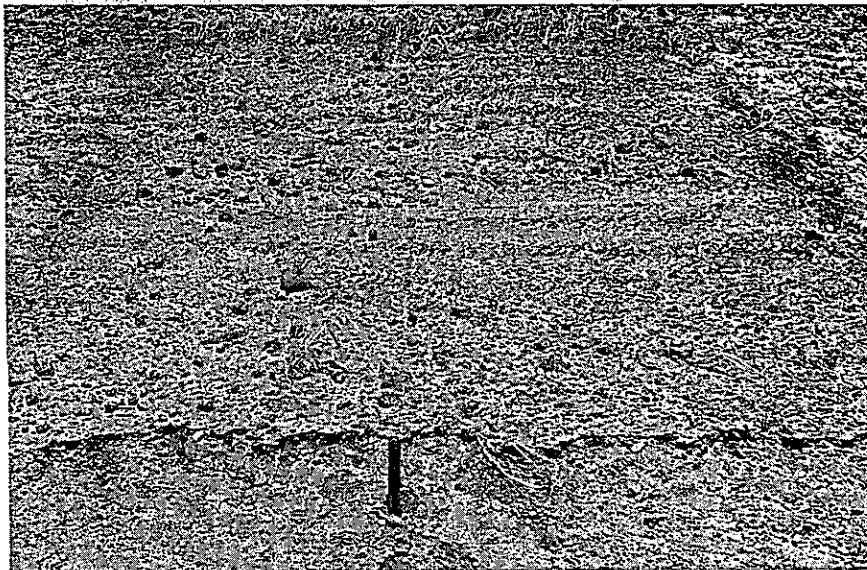
Plate 16

Curasol AE - Seeded

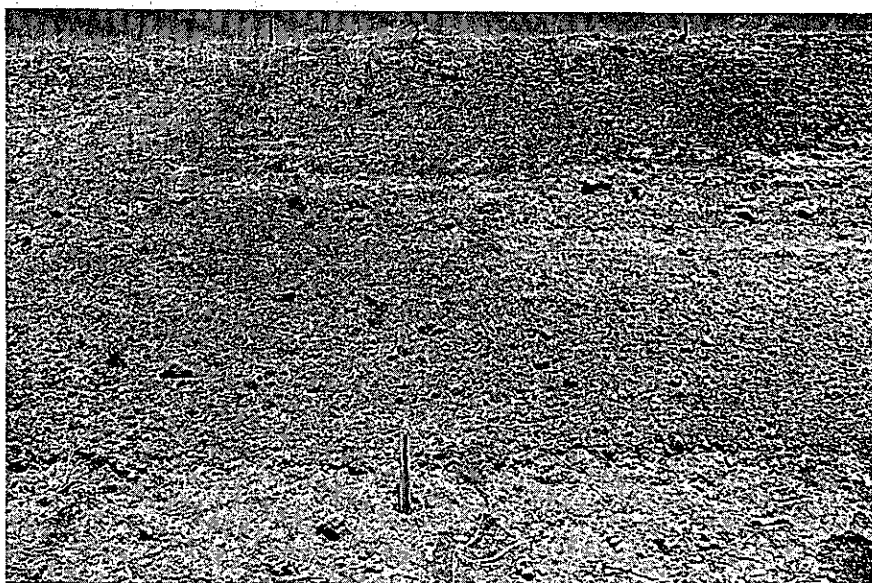
Surfaseal - Bottom half seeded

Surfaseal was applied to only one test plot because of a shortage of material. This test plot is shown in Plate 18. The lower half of the plot was seeded.

Four months of weathering resulted in a thin soft crust on the Surfaseal test plot. The crust on this test plot may provide some protection against erosion. No seeds developed on the test plot but some barley did sprout on the untreated area below the toe. Vegetation, both native plants and barley, sprouted in the roller path. Since no barley was sprayed on the upper portion of the slope, the source of seed is not known.

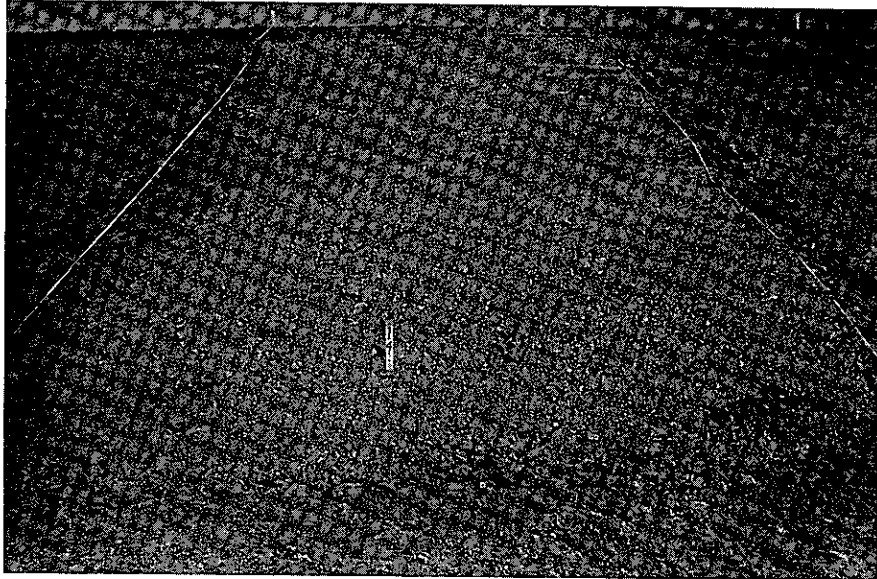
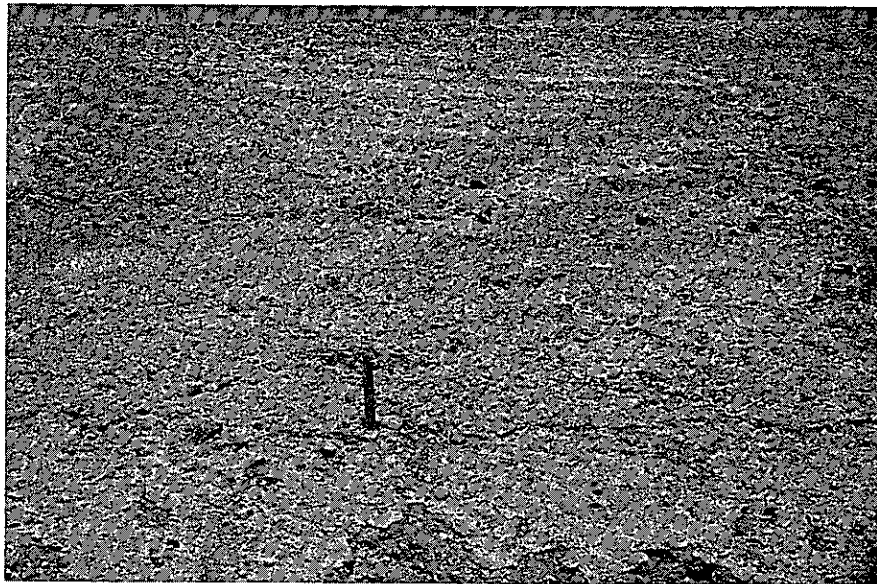
Plate 21

Aquatain - Seeded

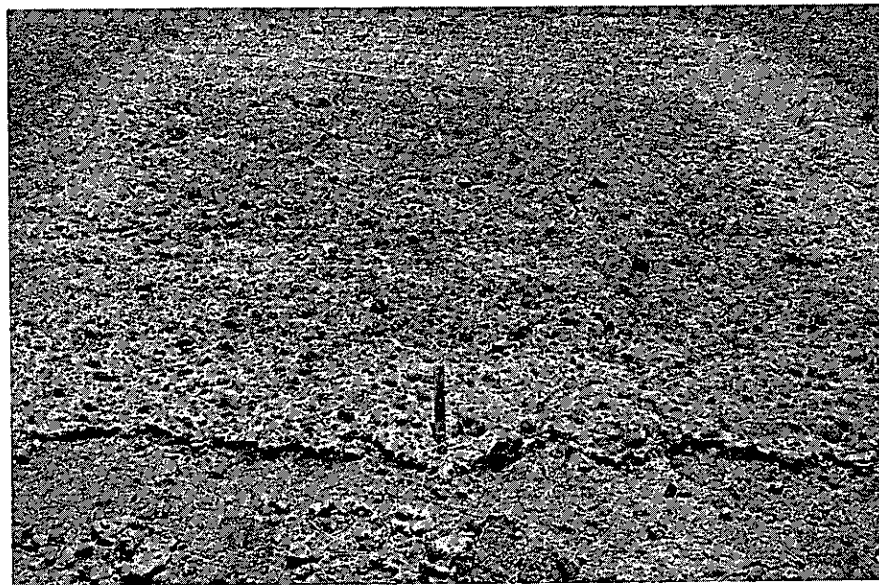
Plate 23

Orzan - Seeded

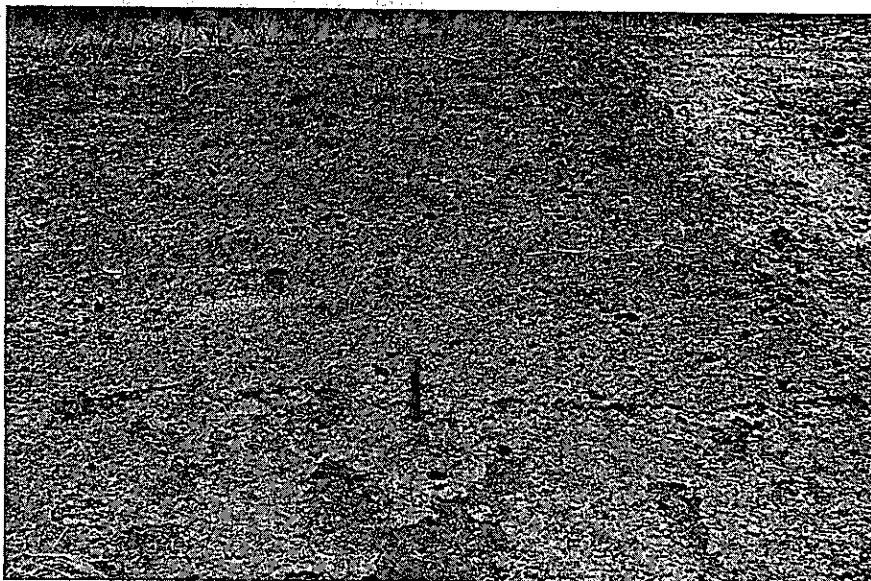
Plate 24

Erode-X

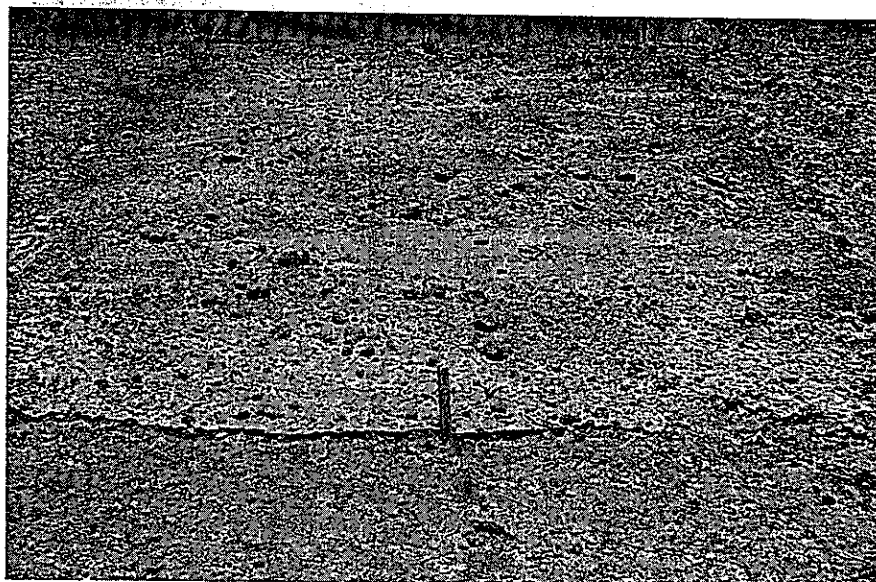
Plate 26

Aerospray 52

Plates 26 and 30 show the test plots that were treated with Aerospray 52.

After four months of exposure, the Aerospray 52 crust was cracked and softened. The unseeded plot was nearly barren except in the track of the straw roller where some native plants had sprouted. The seeded plot had some scattered barley plants but no rye. The crust on this plot has been damaged both by deer and rodents. The combination of the cracked crust, the deer tracks and the rodent damage are expected to permit erosion to take place on this test plot.

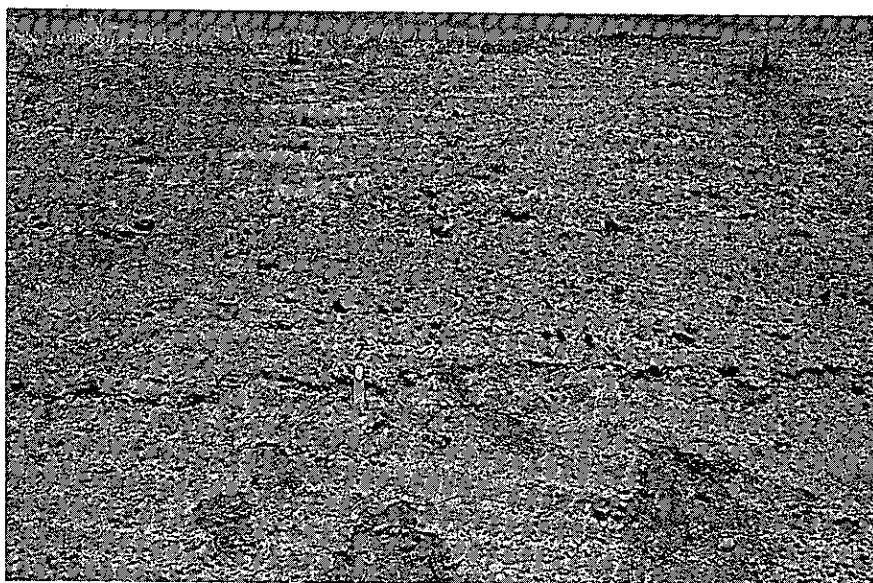
Plate 27

Control

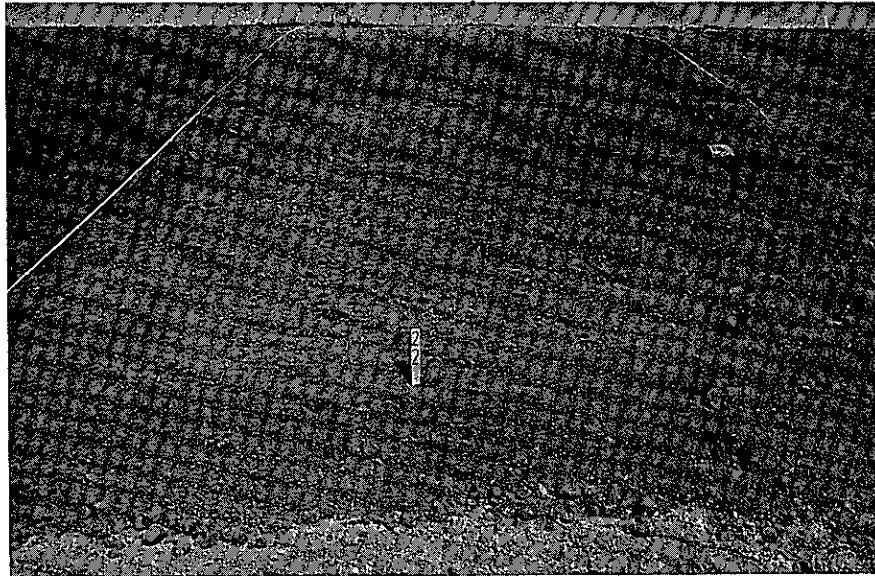
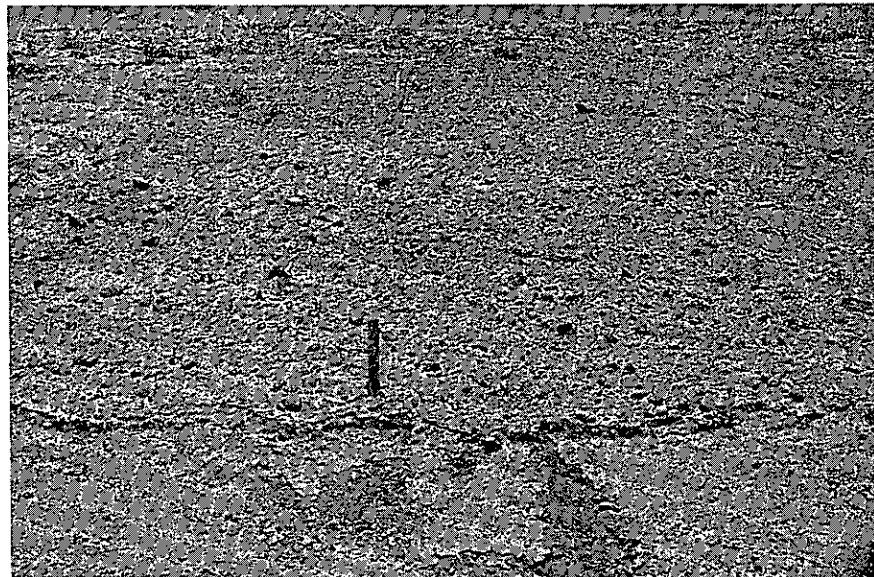
Plate 29

Verdyol Super

Plates 9 and 29 show the Verdyol treated test slopes.

Weathering for four months resulted in a weak crust on both test plots, which probably will not aid in controlling erosion. On the unseeded plot some native plants sprouted, primarily on the roller path. On the seeded plot a very few seeds germinated but some of these were rye grass, which was unusual.

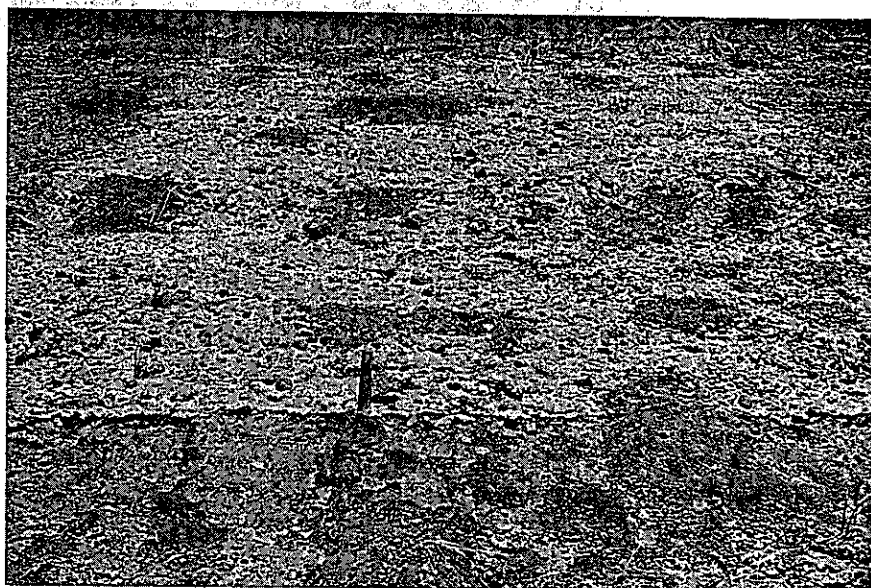
Plate 30

Aerospray 52 - Seeded

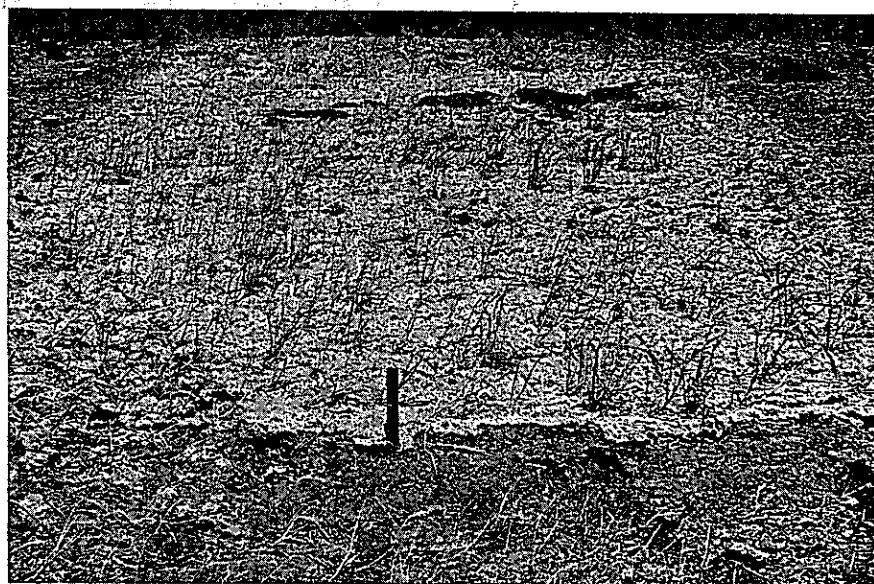
Conwed Fiber - Seeded

The viability of the seeds, at least the barley, is demonstrated by the healthy growth on the Conwed Fiber test plot (see Plate 32). The fertility and plant growing capabilities of the soil are

Plate 32 shows the test plot treated with Conwed Fiber.

After four months, this test plot retained the continuous flexible covering of wood fiber. The plot was severely damaged by the straw roller and rodent activity but will probably not erode because of the continuous nature of the fiber cover and the anchoring effect of the sparse but evenly distributed well developed barley.

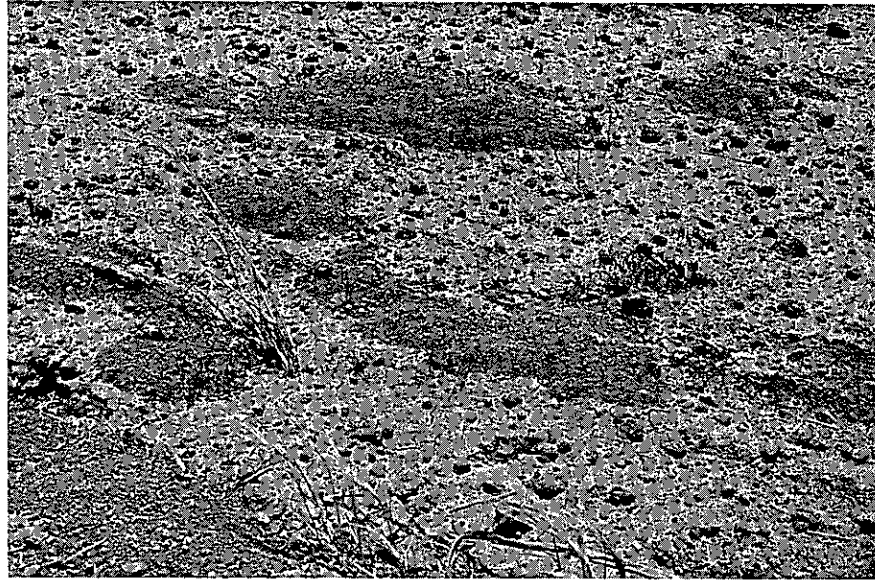
Plate 33 - Rodent Damage

Ground squirrels and/or gophers have damaged the crusts on several test plots (see Plates 33 and 34). Probably the rodent damage is totally independent of the type of material and therefore was not considered in the evaluation of performance.

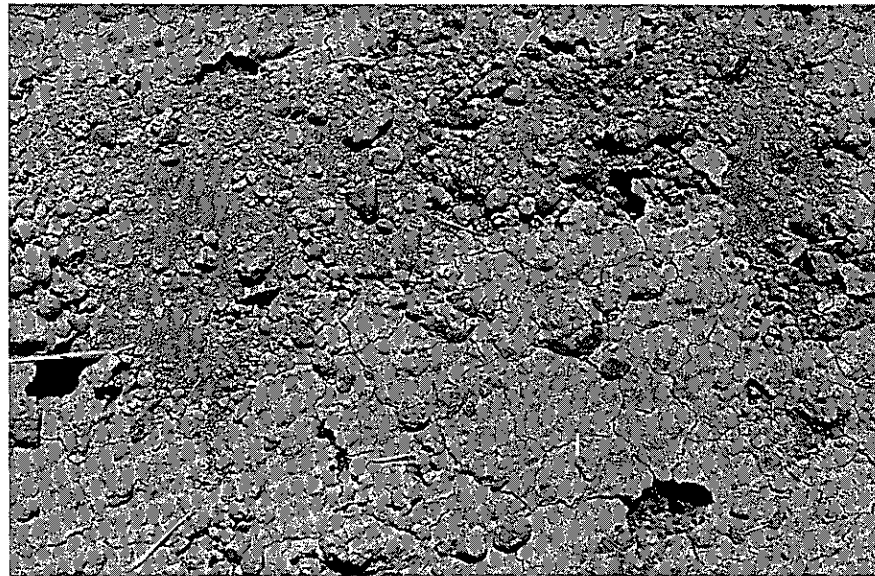
Plate 34 - Rodent Damage
